**PRESERVATION AND URBAN RELIGIOUS INSTITUTIONS:
OPPORTUNITIES AND STRATEGIES FOR THE PRESERVATION OF THE
NINETEENTH STREET BAPTIST CHURCH**

Molly Anne Sheehan

A THESIS

Nineteenth Street Baptist Church Condition Survey

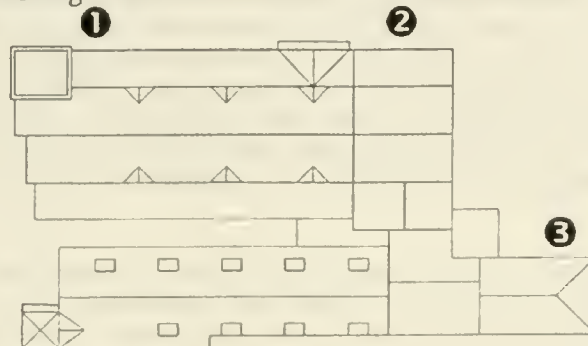
Missing rainwater conductors and clogged drains are causing water to splash on the walls. The damage is particularly severe at the southeast corner of the tower where the downspout is completely missing and the subsurface drain at the sidewalk is plugged up with debris¹. A rainwater conductor from the tower is contributing to the problem by concentrating water into the joint between the tower and the main roof. Another location of serious damage is at the east end of the south wall of the sanctuary². Both the gutter and the downspout have failed, causing considerable amounts of water to get into the interior. Other locations where there are signs of water spilling down the wall suggest that the gutters are blocked³.

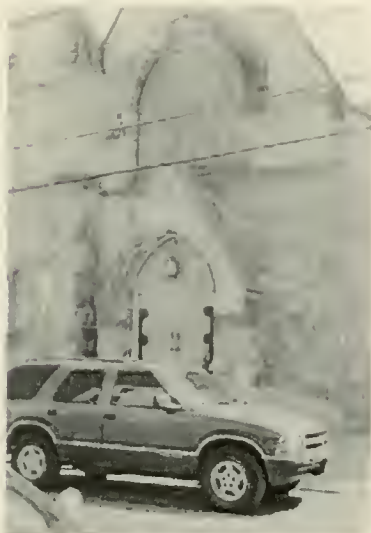
Figure 11 The main entry at the west side of the sanctuary shows surviving stucco above the belt course and exposed, deteriorating serpentine below.

We have endeavored to reconcile the approach to immediate stabilization with an approach to long term conservation. There is a prospect that a single approach can accomplish much of both objectives, however, time being of the essence, we are not convinced that the timing and funding will converge in a single course of action. The prospective technique involves injection grouting and is described in Appendix Three and involves a technique called injection grouting. Wayne Ruth, the proponent of this technique recommends and we concur that we should treat a test section and assess the results. We endorse this notion as a prelude to the longer term solution to the wall as a whole, but are not optimistic that such an approach will meet the urgent time constraints of the collapsing portions.

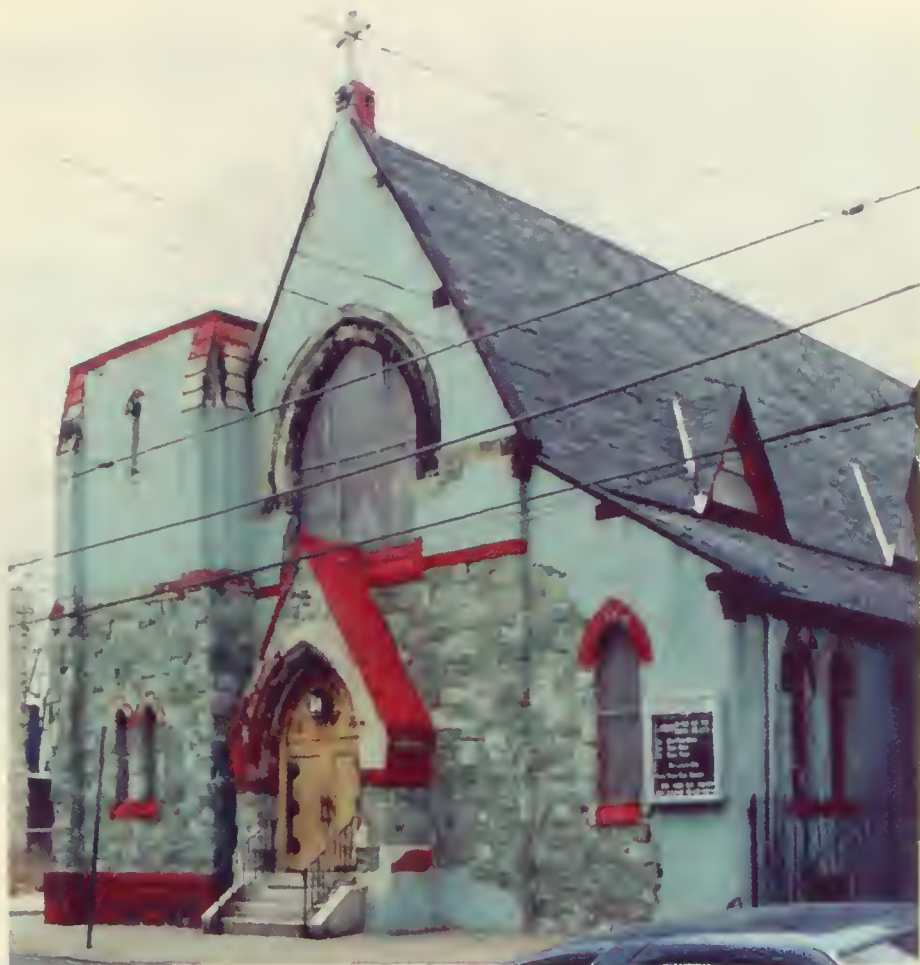
West Façade of Church Building (A)

The original belfry/tower at the corner of 19th Street and Titan Street has been truncated. No access was attainable to the roof area making an estimate of condition impossible. (refer to photographs A, B and F)

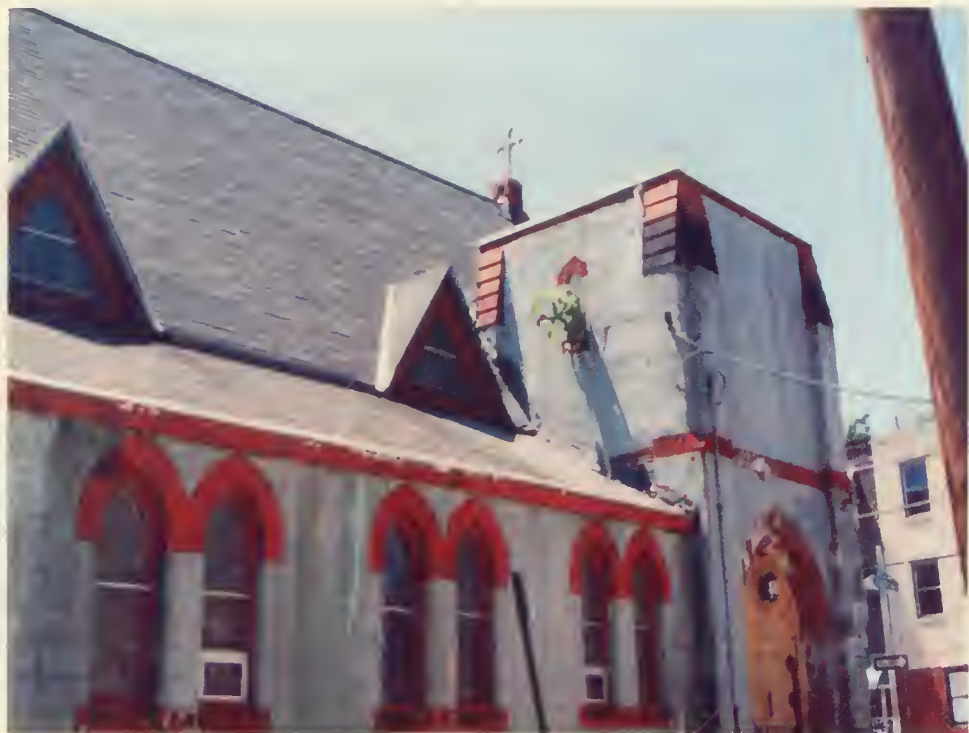
North Elevation of Church Building (H)

Other Features: The back quarter of the north elevation has undergone alteration after a recent explosion. Brick has been inserted to recreate a connection between the masonry wall and the roof. Much patching work is observable in this area. (refer to photograph P) The truncated belfry/tower is observable from this elevation. There is noticeable invasive vegetative growth on the tower. (refer to photographs H and I)

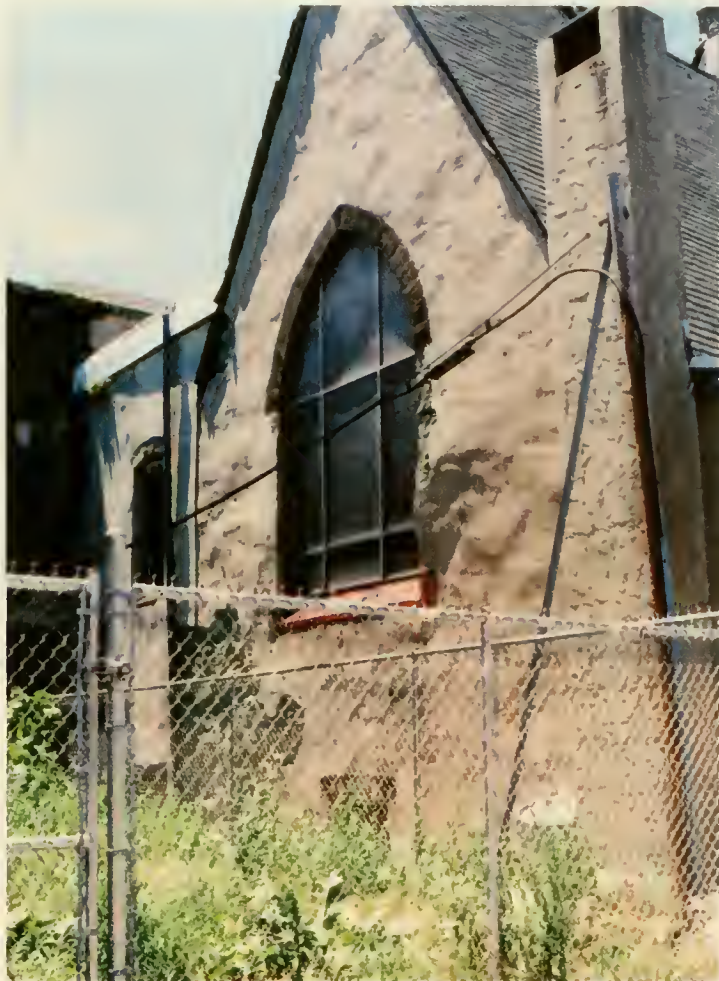
East Elevation of Church Building (Q)

Other Features: This elevation has a chimney at its northeast corner. It too has been coated in stucco. The roofline observable at this elevation has been complicated by an addition. (refer to photograph Q)

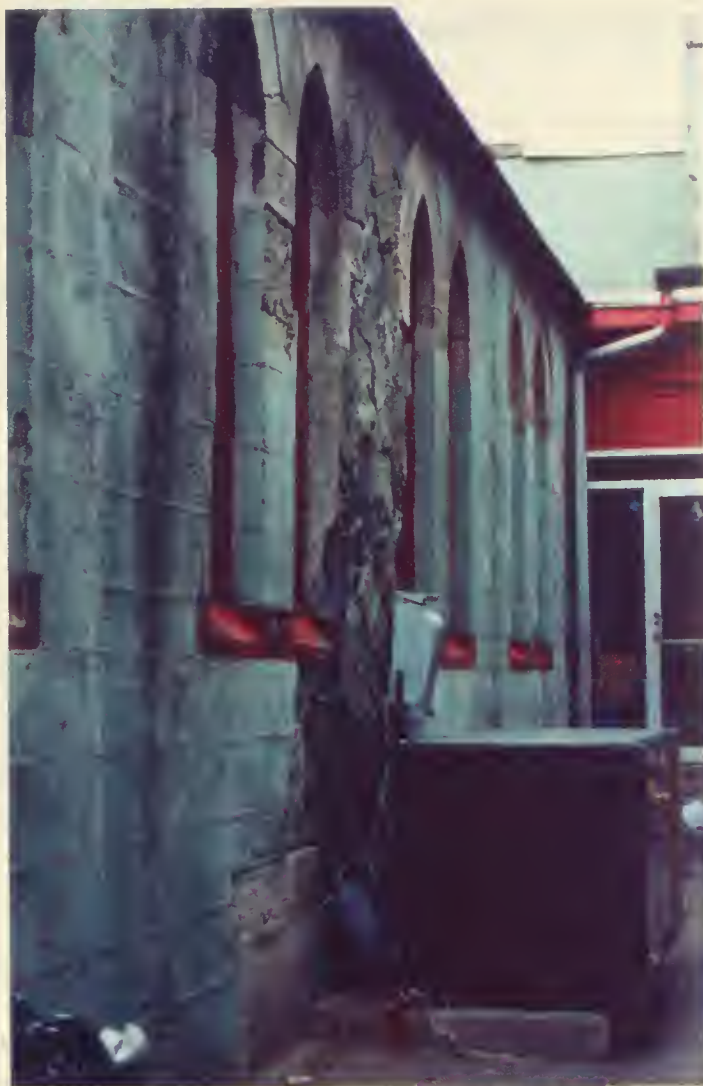
South Elevation of Church Building (U)

Other Features: There is a mechanical system located near this elevation with a box that has been attached to the stucco. (refer to photograph U)
